# Emerald Inspection Services, Inc.

## HOME INSPECTION REPORT

**INSPECTION LOCATION:** 1234 Valley View Drive.  
**CLIENT'S NAME:** Scott and Laura Jones.  
**MAILING ADDRESS:** 4567 Ocean View Parkway.  
**CITY/STATE/ZIP:** Cave Junction, OR 97523.  
**DATE OF INSPECTION:** September 5, 2007.  
**TIME OF INSPECTION:** 9:30am.  
**INSPECTION #:** 080305.  
**CLIENT'S AGENT:** Mary Topseller.

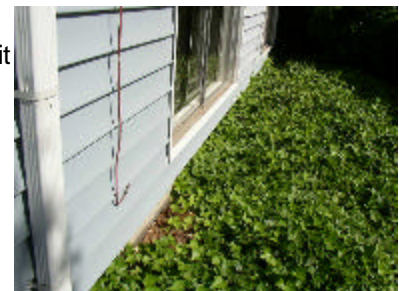
**OTHER CONDITIONS:** There is some minor rot on the tops of some of the protruding beam ends on the front of the house = Recommend installing sheet metal caps over the beam ends to prevent further rotting.

**REMARKS:** We recommend keeping the ivy pruned away from the house to keep it from growing under the siding.

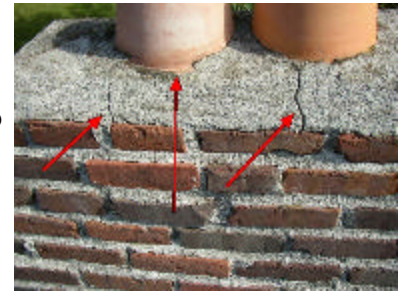
**CONDITION:** Good to Fair. A few bricks with minor surface spalling were noted.

**CHIMNEY CAP:** A rain cap (cover over the flue opening) is not installed, but one is recommended to keep water out of the chimney. A cement chimney cap is installed around the top of the flue liner. Cracks were noted in the chimney cap = Repair is recommended to prevent spalling / damage to the masonry below.

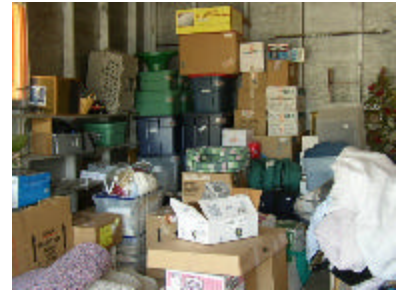
Stored items restrict viewing of the garage area.

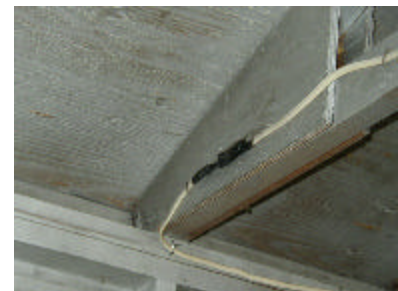
Electrical wiring is covered on the walls to a height of at least a 7 foot height to protect it from damage. There is an improperly made splice in one Romex wire that is not enclosed in a junction box = Potential Hazard. Recommend repair by a licensed electrician.

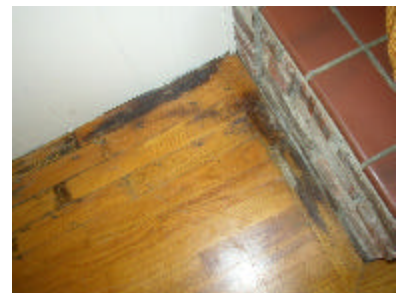
<b>LOCATION:</b>	Main Floor, Left Front.
<b>CONDITION:</b>	Furniture and personal items prevented the full evaluation of floor coverings, wall coverings and outlets.
<b>WALL FINISH:</b>	Paint - General condition is Good.
<b>FLOORING TYPE:</b>	Wood - General condition is Good to Fair. Noted water stains on floor to the left of the fireplace.

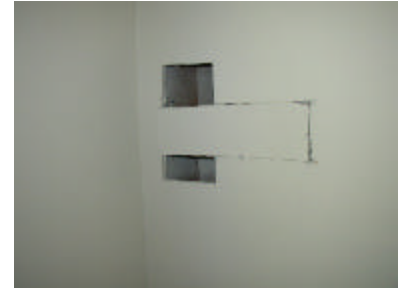
Paint - General condition is Fair.  
There is a hole cut in the wall =  
Repair.

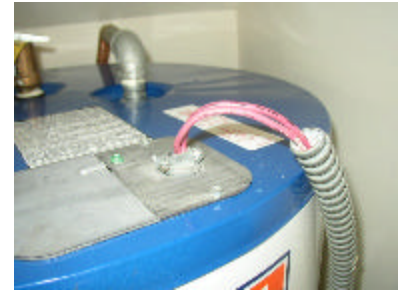
The 220 volt electrical hook-up is routed through flexible conduit, but a connector is not properly installed at the water heater and/or junction box.
